CORPORATE OFFICE

Why LED's don't work on HMMWV's?

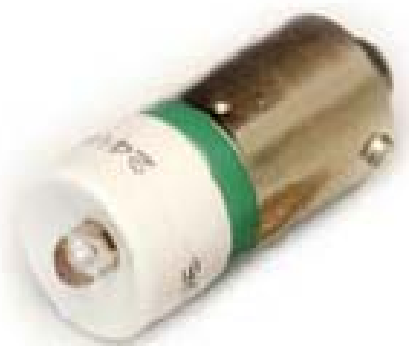
Block the "sneak path" so that the residual electricity cannot flow back to the flasher and cause it to remain in the off position. Replace the incandescent turn signal indicator lamp with a diode – a single LED light! It allows the flasher to function as it was originally designed for the HMMWV, with LED running lights.

Part Number: L1074-ND for 12 Volt

L1080-ND for 24 Volt
